VENTILATING CATHEDRAL CEILINGS TO PREVENT PROBLEMATIC ICINGS AT THEIR EAVES

WAYNE TOBIASSON, THOMAS TANTILLO and JAMES BUSKA

Cold Regions Research and Engineering Laboratory (CRREL)

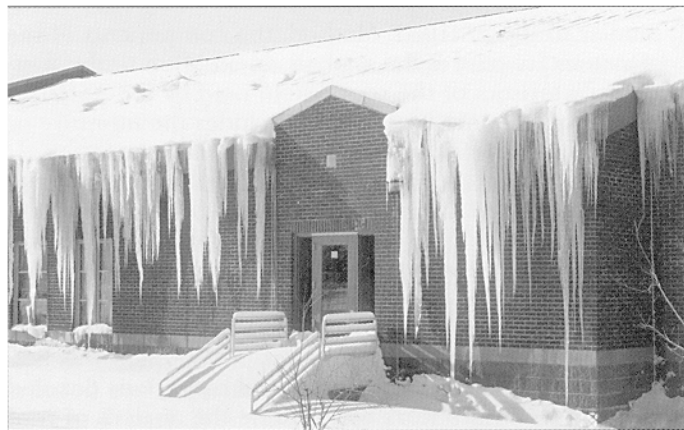
Figure 1. Severe icings along the eaves of a poorly ventilated roof.

When building heat melts the bottom of snow on a sloping roof in cold weather, the meltwater runs downslope to the cold eaves, where icings and ice dams are created (Figure 1). Adding insulation to the roof reduces the amount of heat available to melt snow, but even well-insulated roofs can suffer icing problems because snow is a good insulator. For example, a 70°F (21°C) building with an R30 roof that is covered with 12 inches (305 mm) of snow, which has an R value of 1 ft²h°F/Btu per inch (6.9 mK/W) (i.e., a total R-value of 12 ft²h°F/Btu [2.1 m²K/W]), will experience melting at the base of the snow pack when the outside temperature is 17°F (-8°C) or higher. Only when the outside temperature is lower than 17°F (-8°C) will the base of the snow on that roof be below freezing. With more snow on the roof, the likelihood of creating icicles and ice dams increases. Thus, insulation alone, while playing an important role in reducing icings, has limitations.

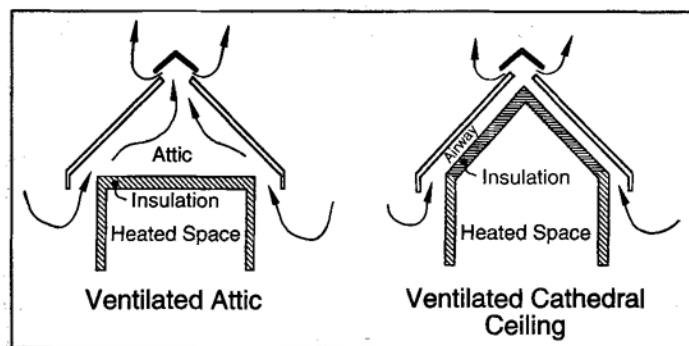
Figure 2. Ventilated attics and cathedral ceilings.

The attic guidelines cannot be used without adjustment for cathedral ceilings, because the narrow airways created above the insulation in such roofs (Figure 2) offer considerable resistance to airflow. However, we have used these guidelines with success to determine the size of attic ventilation systems, then multiplied them by three to five to size the airways of cathedral ceilings [3].

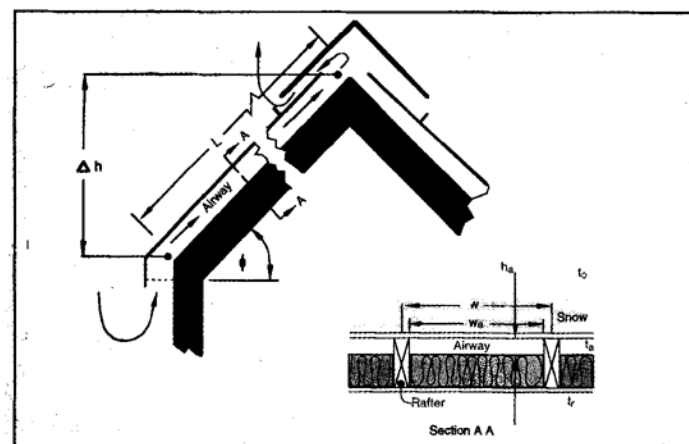
Figure 3. Roof and airway dimensions.

Figure 3 shows various roof and airway dimensions. The following mathematical relationships were developed from equations in the 1997 Fundamentals volume of the ASHRAE (American Society of Heating, Refrigerating and Air-Conditioning Engineers) *Handbook* [4]. Specific ASHRAE equations used are shown in brackets. For example, [C3E11] refers to Chapter 3 Equation 11 in that reference.

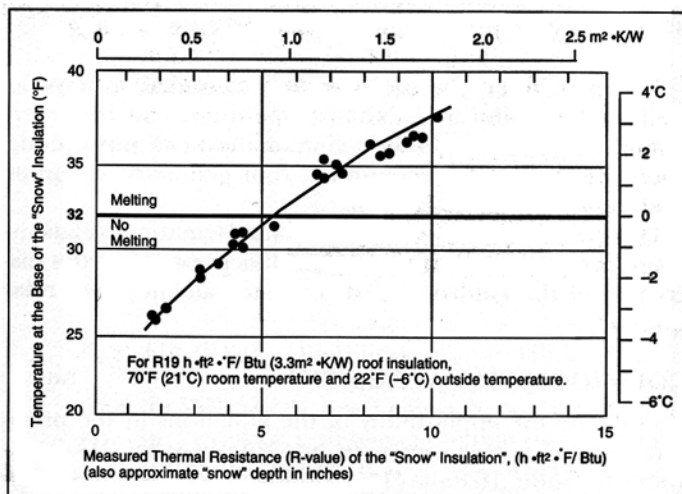
Figure 7. Measured and calculated temperatures of "snow" on the test roof.

Figure 7 plots the net insulating ability of the "snow" for tests with no airway vs. the temperature at the base of the "snow." Assuming that the thermal resistance of snow is about 1 ft²h°F/Btu per inch (6.9 mK/W), we can also think of the R-value shown in Figure 7 as snow depth in inches. The curving line in that figure is the trend line for those data points. Figure 7 indicates that, for these conditions (heated space at 70°F [21°C] and R19 [3.3 m²K/W] insulation in the roof), it takes very little "snow" (only about 5 inches [about 130 mm]) to raise the temperature at the base of the snow above its melting point (32°F [0°C]) at the design condition (22°F [-5.6°C] outside). As more snow is present on the roof, the temperature at the base of the snow increases. The temperature there stays lower for roofs containing more insulation. However, for a roof with a thermal resistance (R-value) of 40 ft²h°F/Btu (7.0 m²K/W), problematic melting can occur when just a foot of snow is present.

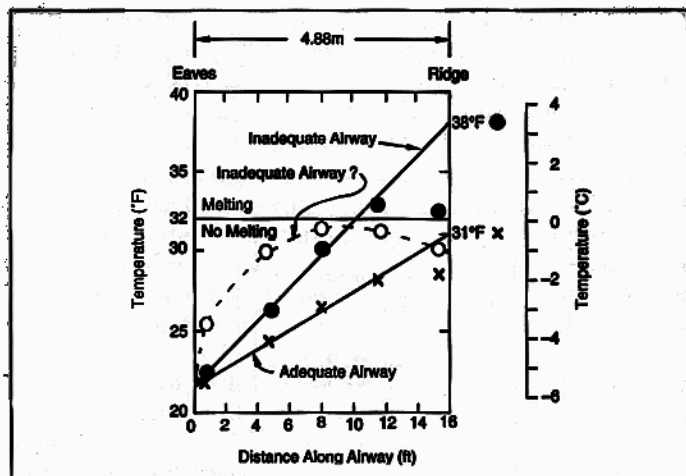
Figure 8. Typical profiles of airways tested: one adequate, two inadequate.

As shown in Figure 4, temperatures were measured at five places along the top of each airway from its eaves to its ridge. Figure 8 shows three typical temperature profiles. A uniform increase in temperature is evident along two of the airways, except near the ridge. The temperature sensor in each airway near the ridge was 6 inches (152 mm) in from its end. It consistently was colder than would be expected from the trend defined by the other four sensors in the airway. It appears that a loop of cold air was entering the airway at the ridge under the out-flowing warm air, cooling the last few feet of the airway. We have used a straight line extrapolation of information from the other four sensors in each airway to define the temperature expected at the top of the airway (hereinafter called the "exit temperature"). If the exit temperature exceeded 32°F (0°C), that airway was considered to be inadequate, since snow on the roof above would be melted, causing icings at the eaves.

The airway represented by the upper straight line in Figure 8 ($h_a = \frac{1}{2}$ inch [13 mm], slope = 44 degrees) had an exit temperature of 38°F (3.3°C) and thus was inadequate. The airway represented by the lower straight line in Figure 8 ($h_a = 1$ inch [25 mm], slope = 30 degrees) had an exit temperature of 31°F (-0.6°C) and thus was big enough to avoid snow melt and icings.

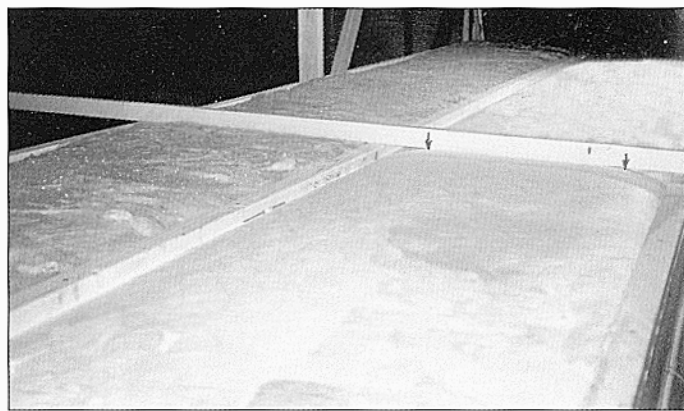
Figure 9. One-inch- (25-mm-) high airways mostly blocked by expansion of fibrous glass insulation.

The batt insulation without the air barrier over it expanded to fill the 1-inch- (25-mm-) high space intended to be an airway. We had expected some expansion, but we did not expect this much.

The fibrous glass insulation in the adjacent airway was exerting similar expansion forces on the air barrier when we installed it. Had this air barrier been installed before the fibrous glass was installed, which would be the normal sequence on most real roofs, it is logical that it could have been installed somewhat tighter because no fibrous glass would be bowing it during its installation. We tried to install this air barrier very tightly, thus much of what we subsequently experienced can be expected, all things considered, on most real roofs. Figure 9 shows these two airways just prior to our placing the plywood roof deck on them. The unrestrained fibrous glass has risen more than 1 inch (25 mm) and is even forcing its way up around the straight edge, which rests on the top of the 1-inch- (25-mm-) high strips screwed to the "2 x 6" rafters to create the airway. The air barrier has also been forced up by the fibrous glass so that over most of the airway (between the two arrows on the straight edge) it is pressing against the bottom of the straight edge. Thus, the airway above the air barrier was of very limited size, and no airway existed when no air barrier was present.

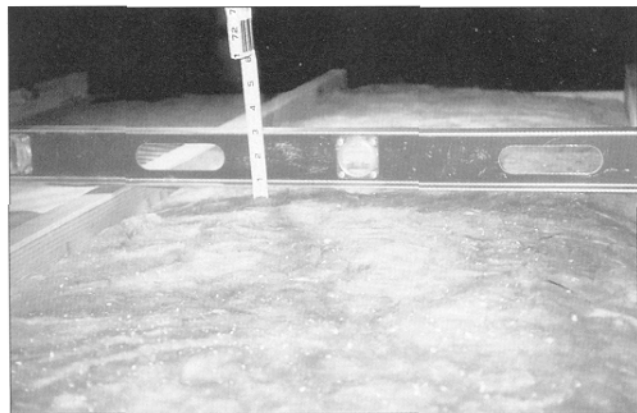
Figure 10. Expanding fibrous glass came close to completely blocking this 2-inch (51-mm) high airway.

We next increased the height of the spacers to 2 inches (51 mm). The fibrous glass without an air barrier continued to expand upward. As shown in Figure 10, it almost filled the 2-inch (51-mm) space intended to be an airway. Over the center half of the airway, it came within ¼ inch (13 mm) of completely blocking it. This airway received some ventilation but exit temperatures were still quite high (35 to 39°F [1.7 to 3.9°C]).

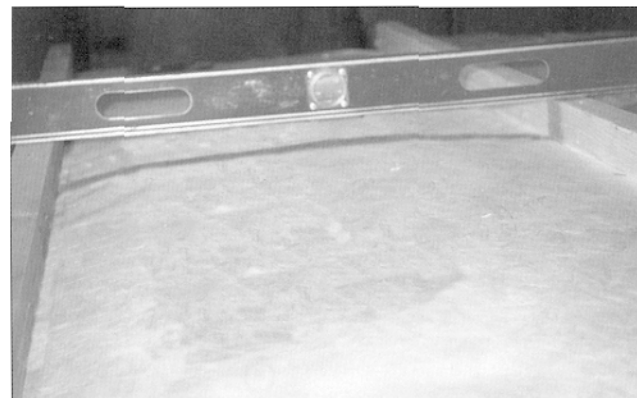
Figure 11. Air barrier reduced the intrusion of fibrous glass insulation into this airway.

In the adjacent airway, the air barrier resisted the fibrous glass expansion. As shown in Figure 11, at no place did this air barrier touch the underside of the roof deck. It was ¼ inch (19 mm) below the underside of the roof deck along the centerline of the airway.

shown in Figure 11 (lower line in Figure 12) warmed to above 32°F (0°C) but at test slopes of 30 and 44 degrees it passed the test (i.e., it remained below 32°F [0°C] throughout its length). With the bowing of the air barrier, its average height was about 1 inch (25 mm).

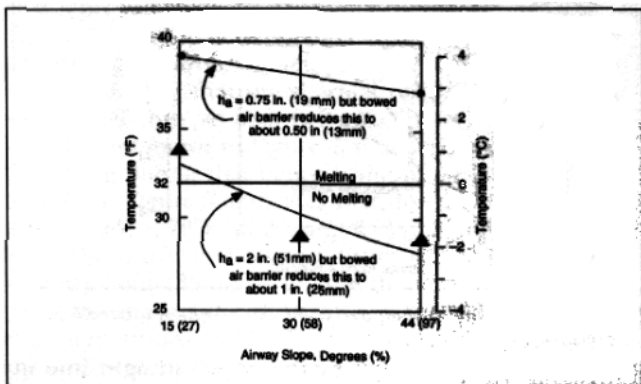
Figure 12. Exit temperatures for two airways with bowed air barriers.

Results for this and another airway with an air barrier are presented in Figure 12. At a slope of 15 degrees the airway

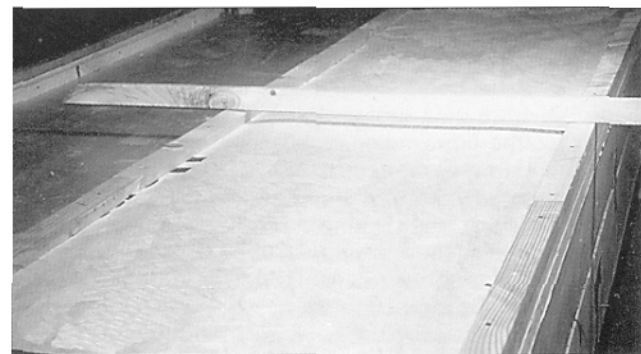
Figure 13. This air barrier, placed over already expanded fibrous glass, was only bowed upward ¼ inch (6 mm).

We investigated one other means of creating "guaranteed" airways using an air barrier over fibrous glass insulation. We removed the air barrier previously discussed and installed a new air barrier on top of 2-inch- (51-mm-) high spacers. We then added ¾-inch (19-mm) spacers over it. Figure 13 shows how little that air barrier was bowed by the relaxed fibrous glass. The airway was at least ¼ inch (13 mm) high across its width. Figure 12 shows that this narrow airway provided inadequate ventilation. Nonetheless, providing space below the airway for expansion of fibrous glass insulation can be beneficial. Air barrier bowing can decrease the effective height of an airway by 1 inch but, by providing space into which the fibrous glass insulation can expand below the air barrier, this loss can be reduced to about ¼ inch (6 mm). Thus, providing space for fibrous glass expansion can create a ¾-inch (19 mm) deeper airway when its bottom is an air barrier.

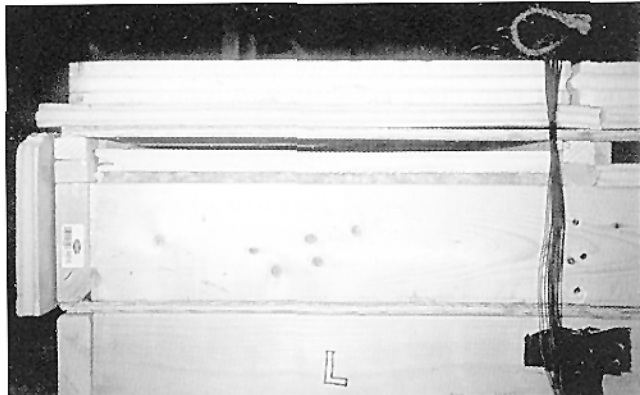
Figure 14. One-inch- (25-mm-) thick extruded polystyrene insulation boards (the light horizontal band below the dark airway) were not bowed by the fibrous glass insulation below. This airway is only ½ inch (13 mm) high. The insulation boards guaranteed its existence. Also note that a gap exists between the plywood roof deck and the "snow" insulation over the right third of this airway. That may explain why the snow insulation provided less thermal resistance than expected.

We constructed guaranteed airways ½, 1 and 2 inches (13, 25 and 51 mm) high using spacers and extruded polystyrene insulation boards. The boards increased the amount of insulation in these tests from about R19 to R24 (3.3 to $4.2 \text{ m}^2\text{K/W}$). Figure 14 shows the ½-inch- (13-mm-) high airway.

As Figure 14 shows, the ends of the test airways did not contain inlet and exhaust structures, which would have somewhat reduced airflow up the airways. To obtain an appreciation of how much such features would decrease the ability of these airways, a few tests were re-run with these added. Figure 16 shows the inlet and exhaust structures before they were installed. Each contains two strips,

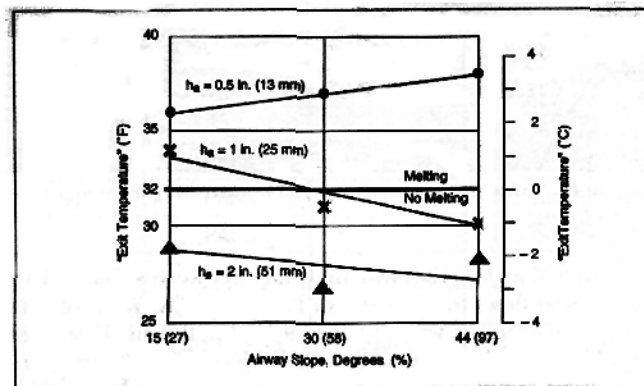
Figure 15. Exit temperature for airways with bottoms of extruded polystyrene insulation boards.

Results of these three tests are presented in Figure 15. The 2-inch- (51-mm-) high airway performed adequately at slopes from 15 to 44 degrees. The 1-inch (25-mm) airway

did not suffice at 15 degrees but it did at slopes of 30 and 44 degrees. This is consistent with the findings for the nominal 1-inch (25-mm) airway created with 2-inch (51-mm) spacers and a bowed air barrier as shown in Figure 11. The ½-inch (13-mm) airway was inadequate at all slopes, as was the nominal ½-inch (13-mm) airway with an air barrier (Figure 13). The slopes of the lines for the 1- and 2-inch- (25- and 51-mm-) high airways in Figure 15 are understandable: As slope increases, these airways perform better. The ½-inch- (13-mm-) high airway, also shown in that figure, does not follow this trend. We expect that the air flow complexities mentioned when discussing Figure 8 explain why this inadequate airway behaves as it does.

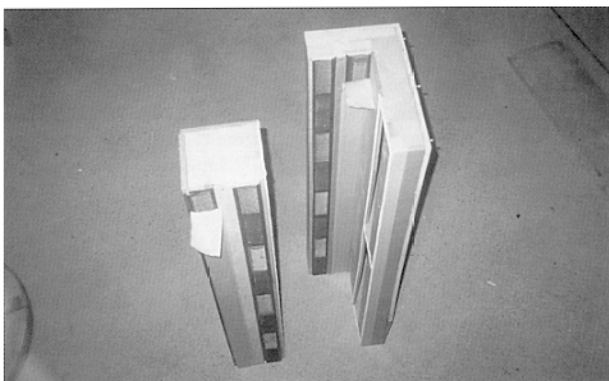
Figure 16. Intake and exhaust structures before being installed on the test roof.

each providing 9.2 square inches of net free openings per running foot ($19.5 \text{ mm}^2/\text{running mm}$). Some tests were run with one strip covered with tape, and others were run with both strips open. Figure 16 shows one strip open and the other covered with tape except at its upper end, so its presence can be detected in the photograph. Figure 17 shows the exhaust structure mounted at the top of an airway that is being tested at a slope of 44 degrees. One of those strips is covered with tape.

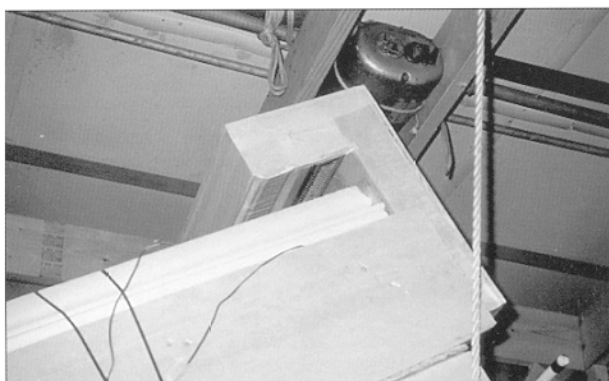
Figure 17. Exhaust structure mounted on airways being tested at a slope of 44 degrees.

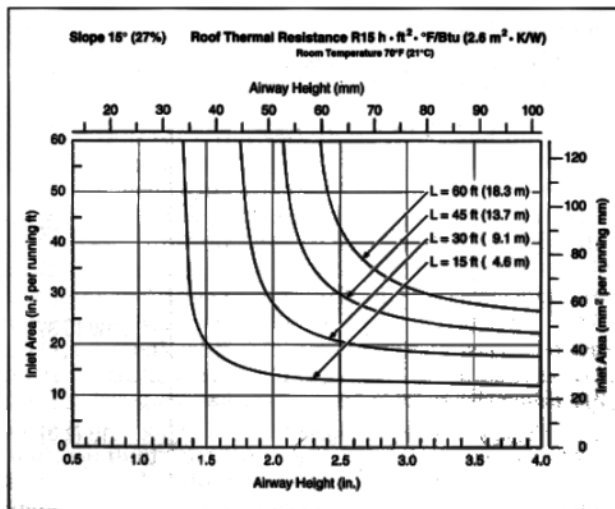
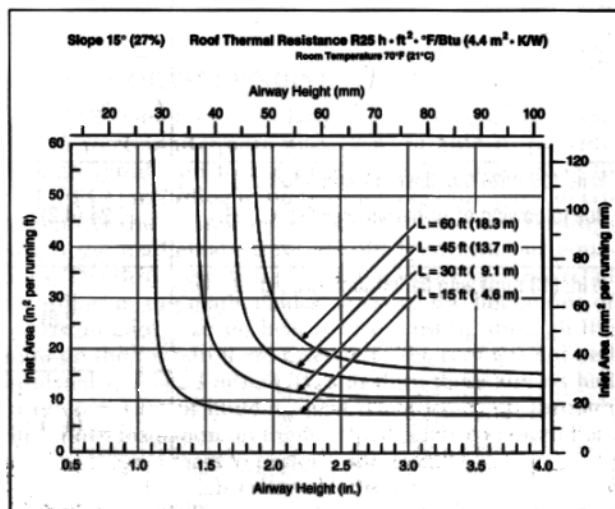
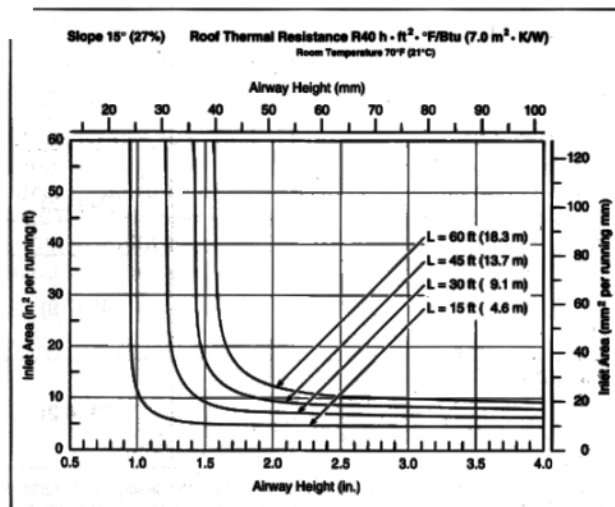
Figure 18. Airway heights and inlet areas for cathedral ceilings with a slope of 15 degrees.

The curves in Figures 18 through 21 were developed for airways located between 1½ inch- (38-mm-) wide rafters spaced 16 inches (406 mm) on center. When rafters are spaced farther apart, the airways occupy a slightly larger portion of the roof area and will perform slightly better. However, because the improvement is minimal, it is suggested that the curves be used unmodified for other rafter spacings.

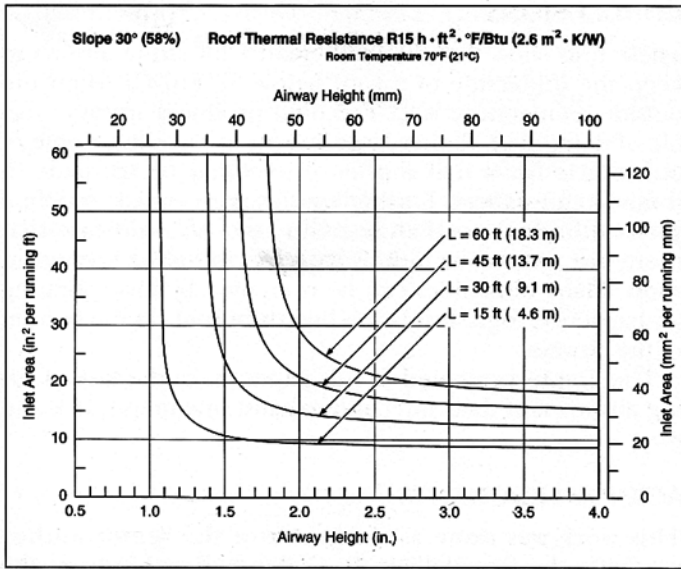
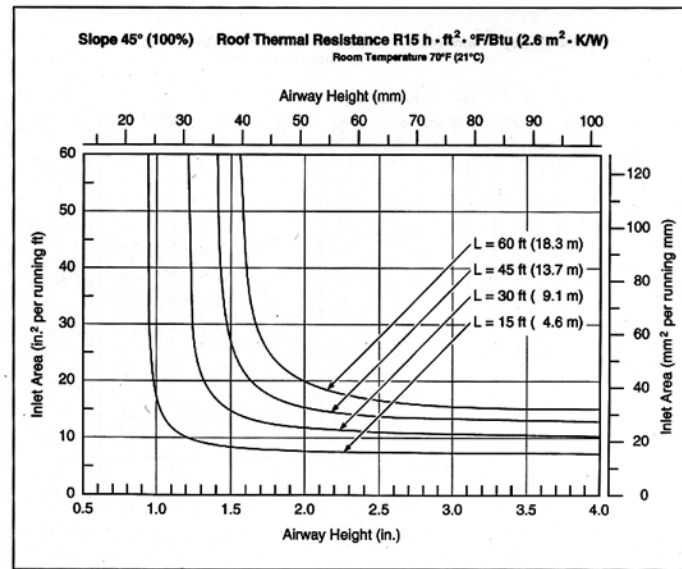
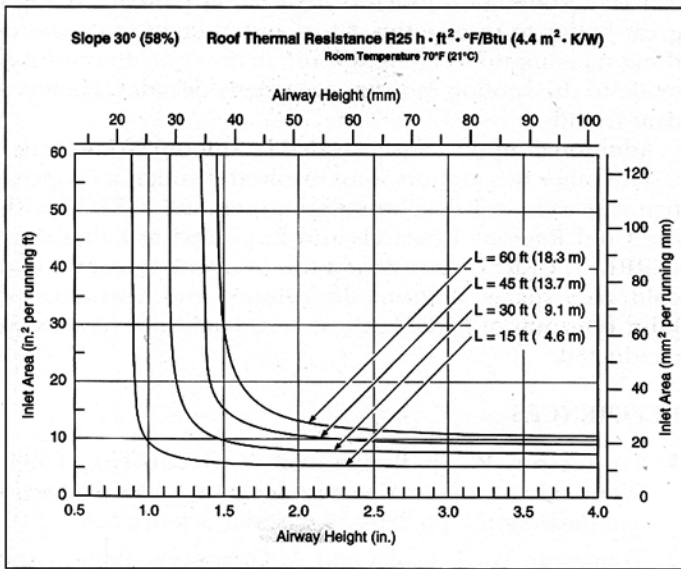
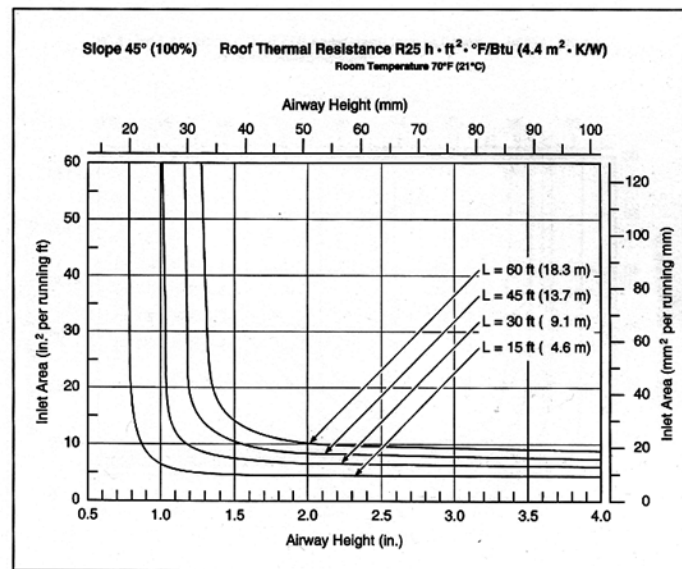
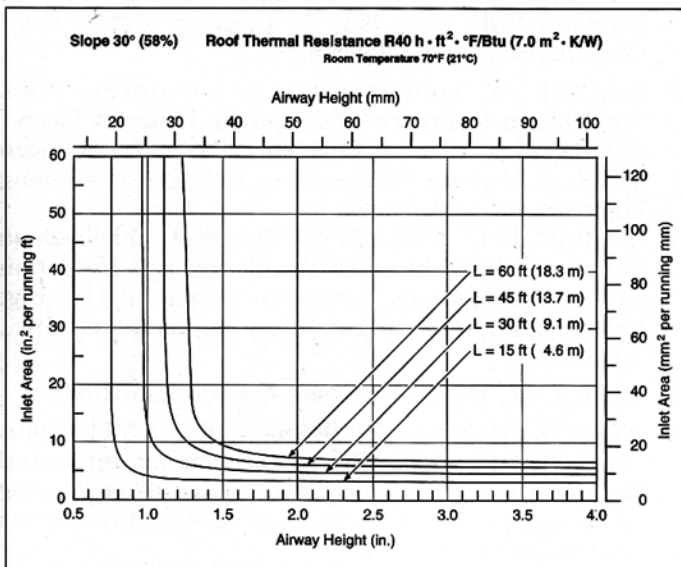
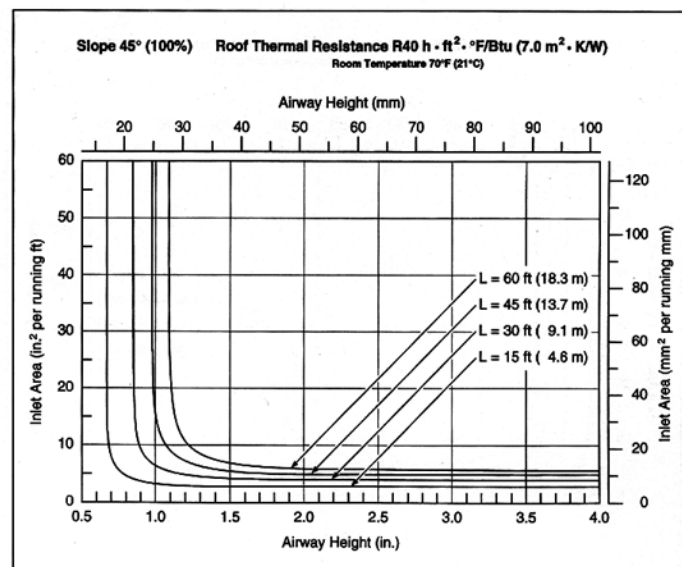
Figure 19. Airway heights and inlet areas for cathedral ceilings with a slope of 30 degrees.

Figure 20. Airway heights and inlet areas for cathedral ceilings with a slope of 45 degrees.

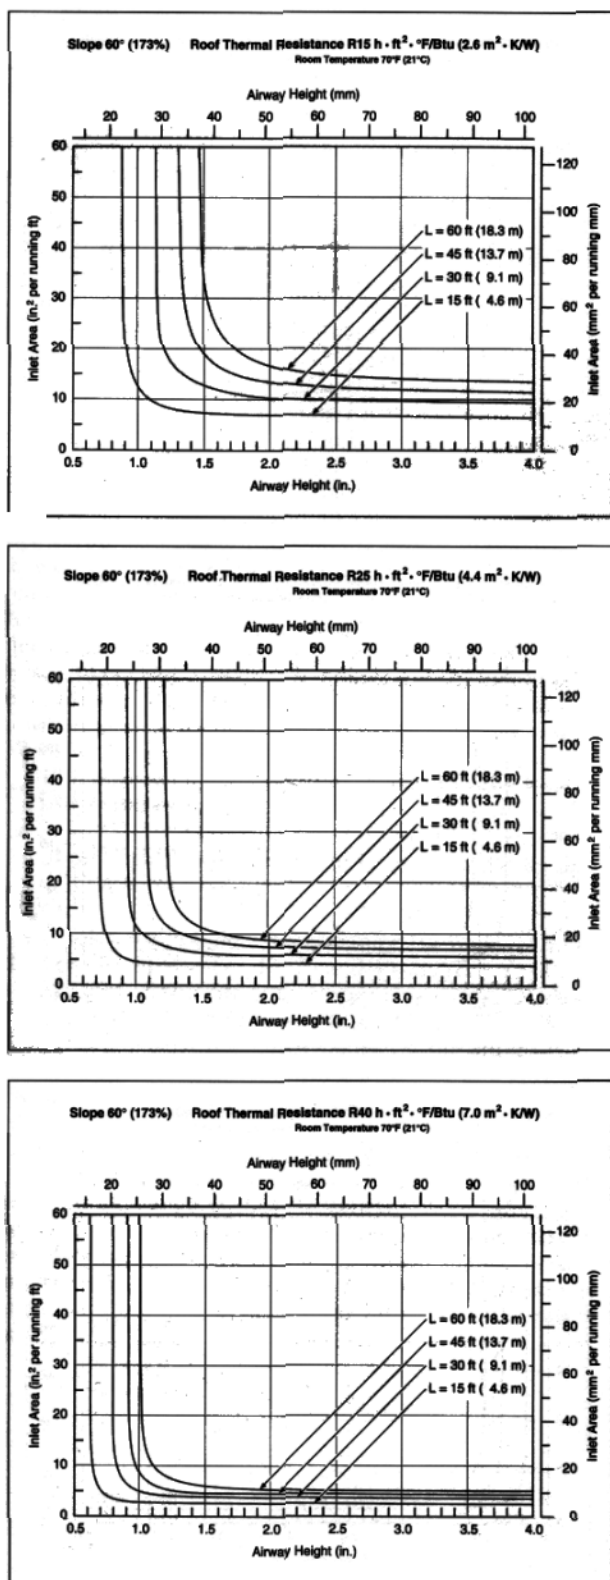
Figure 21. Airway heights and inlet areas for cathedral ceilings with a slope of 60 degrees.
